Thorntown Wastewater Treatment Plant Liner Installation

Town of Thorntown
Boone County, Indiana
November, 2023

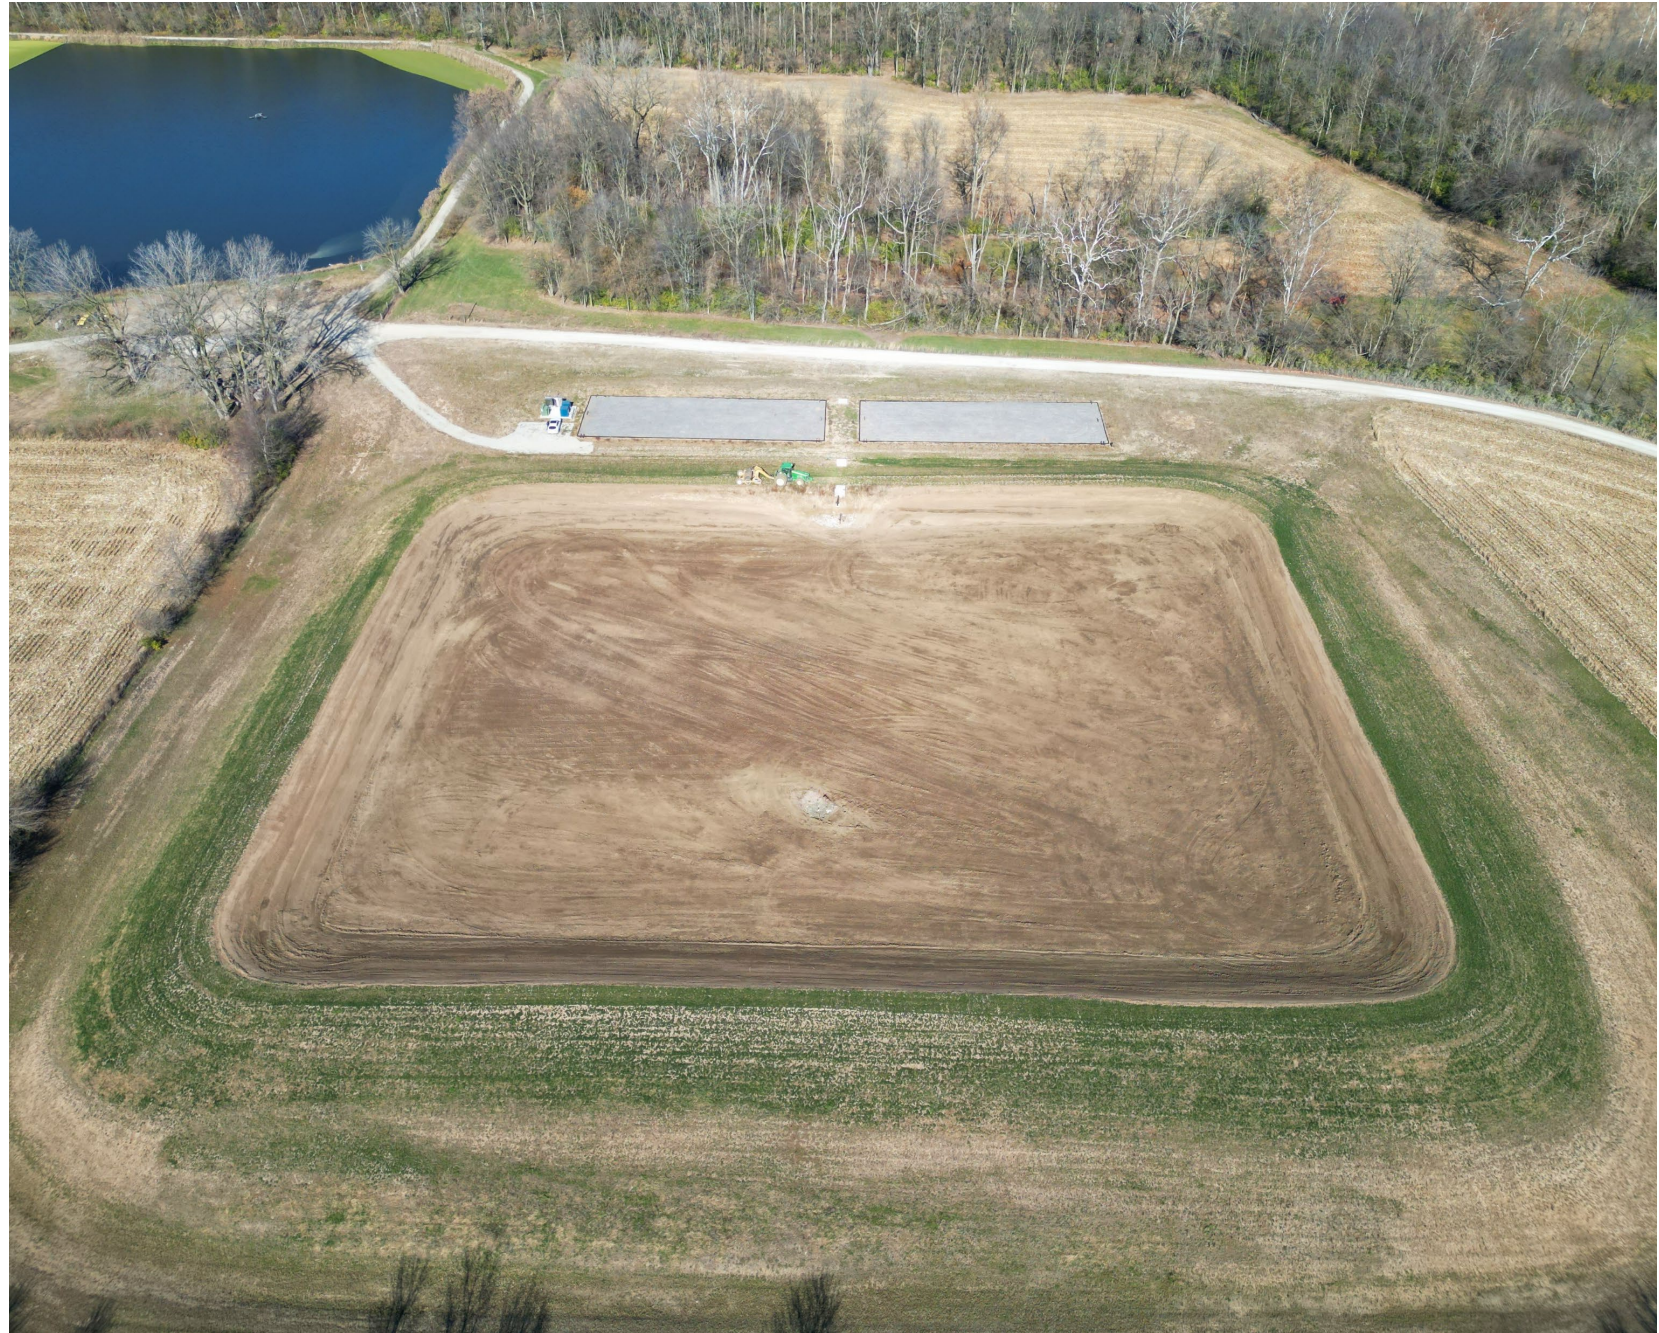
- The entire lagoon was re-graded
 - Weeds were cut down
 - Sidewall erosion was repaired
 - Cracks and sink holes in the soil were repaired
 - The bottom profile was sloped towards the northwest corner to allow for a single pump location to remove water after a rain event
- After grading, the surface was rolled smooth and compacted using multiple passes with a drum roller

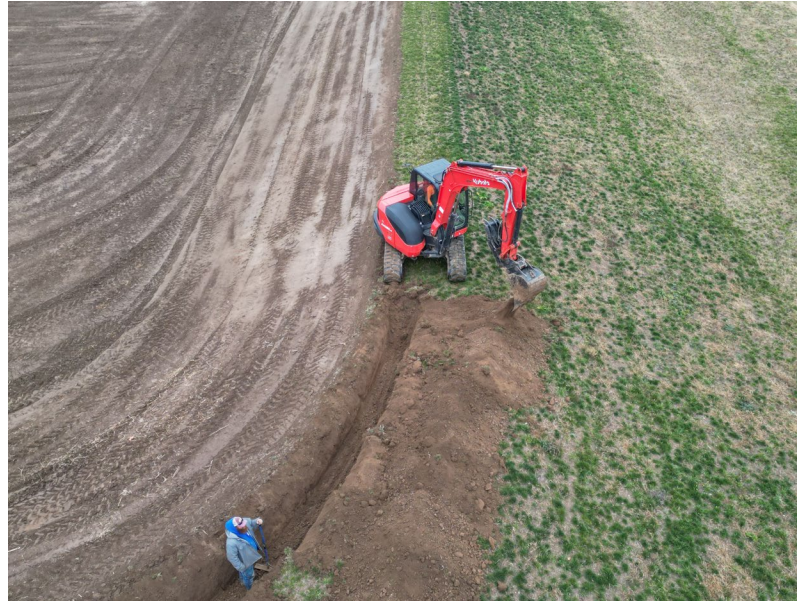
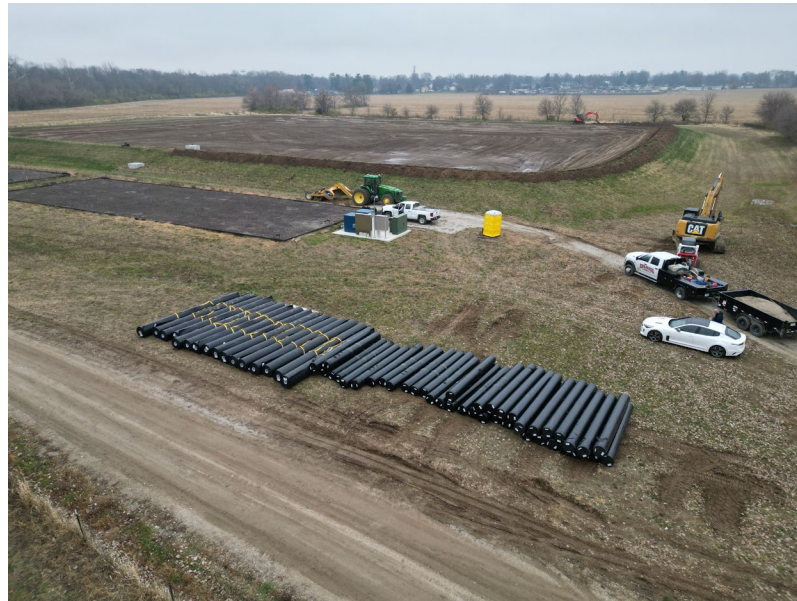
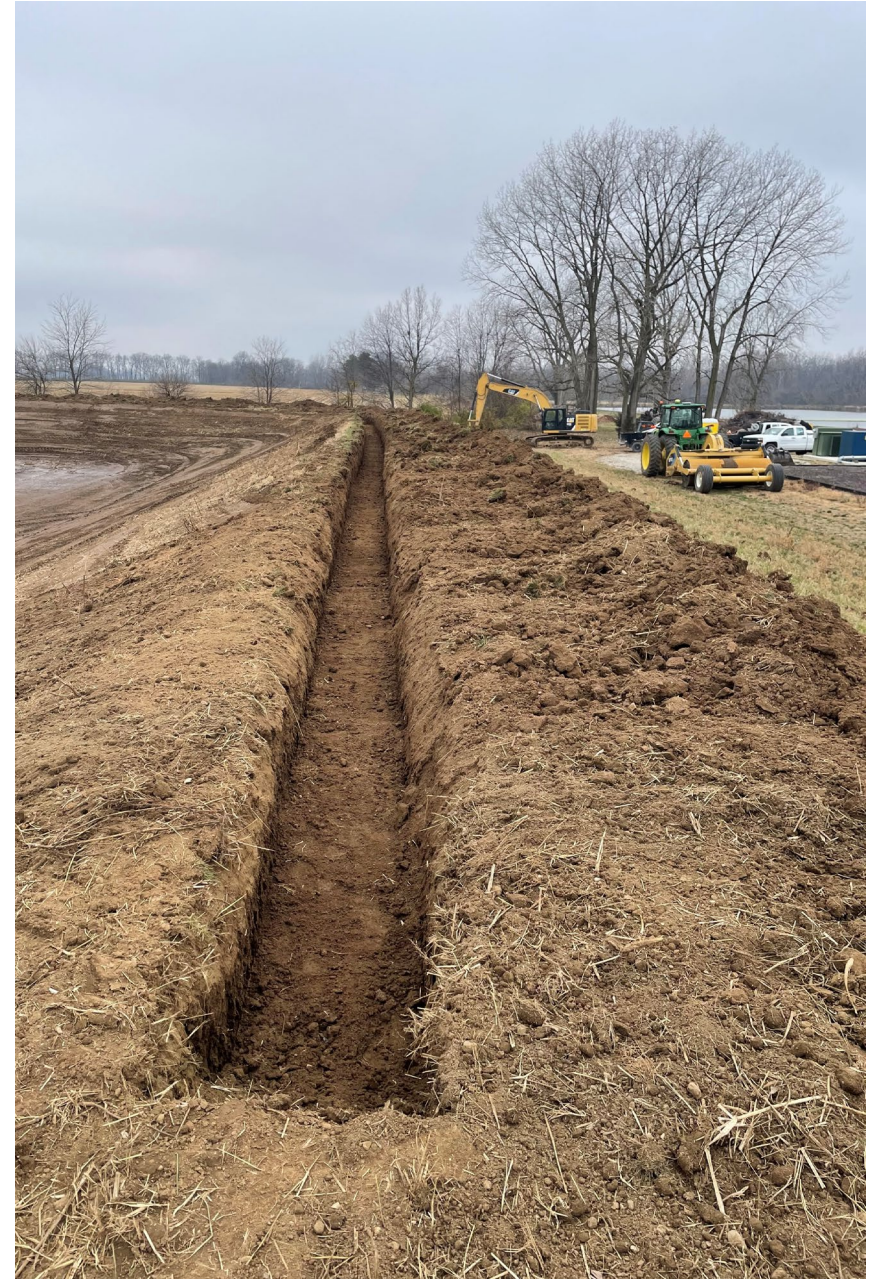
- The geotextile fabric and HDPE liner were shipped to the jobsite via three flat-bed trailers
- A two-foot wide by two-foot deep anchor trench was cut into the top of the dike to receive the geotextile fabric and HDPE liner

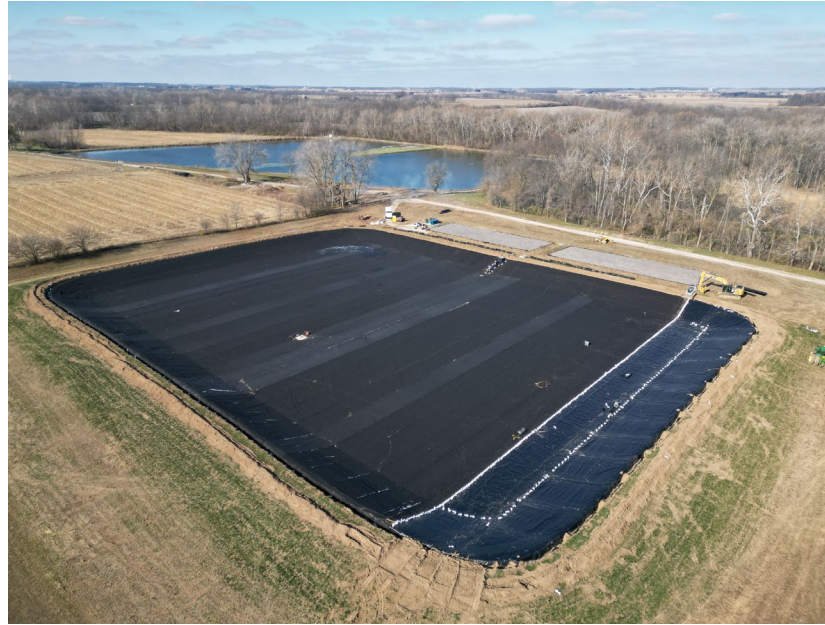
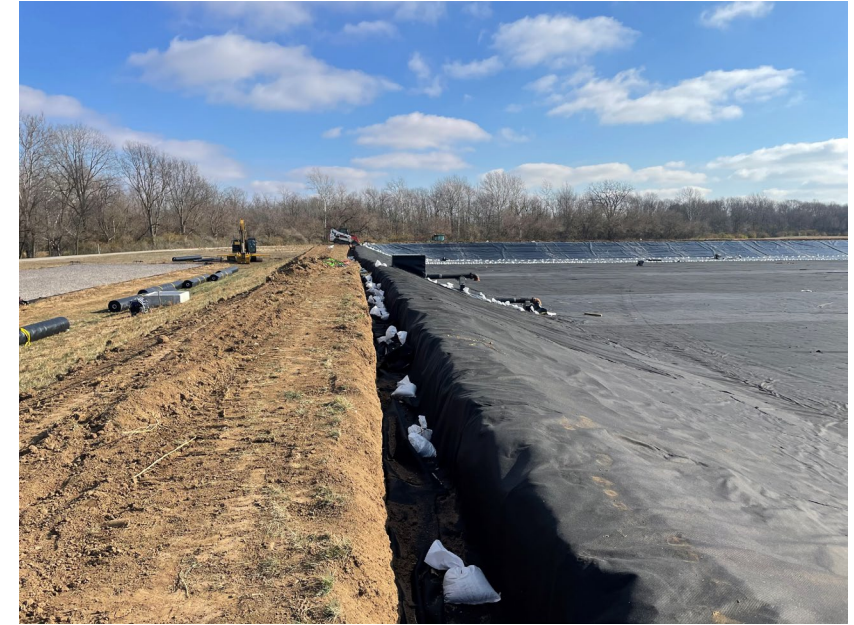
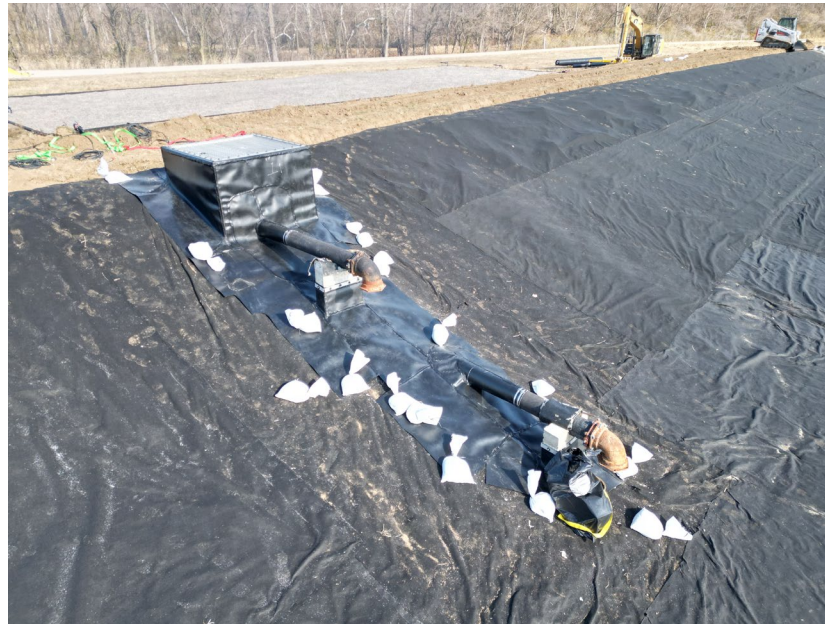
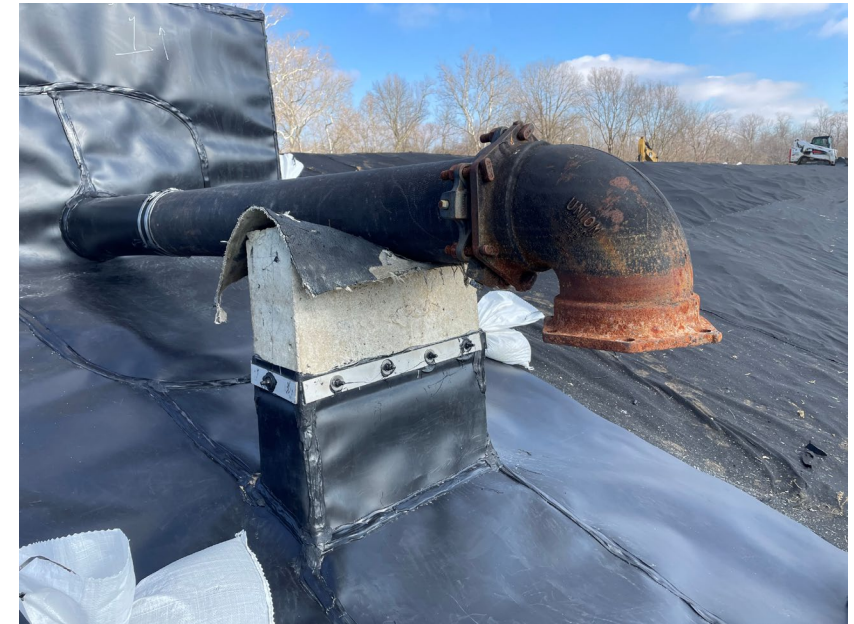
- The installation begins by installing the geotextile fabric on the freshly prepared soil base
- The liner materials in installed in a North-South orientation with the ends extending into the anchor trench
- The liner material is stretched to minimize wrinkles and staked in the anchor trench with rebar (sandbags were later removed)
- The liner around the withdrawal structure with installed with pipe boots, batten bars, and extrusion welds for a water-tight seal

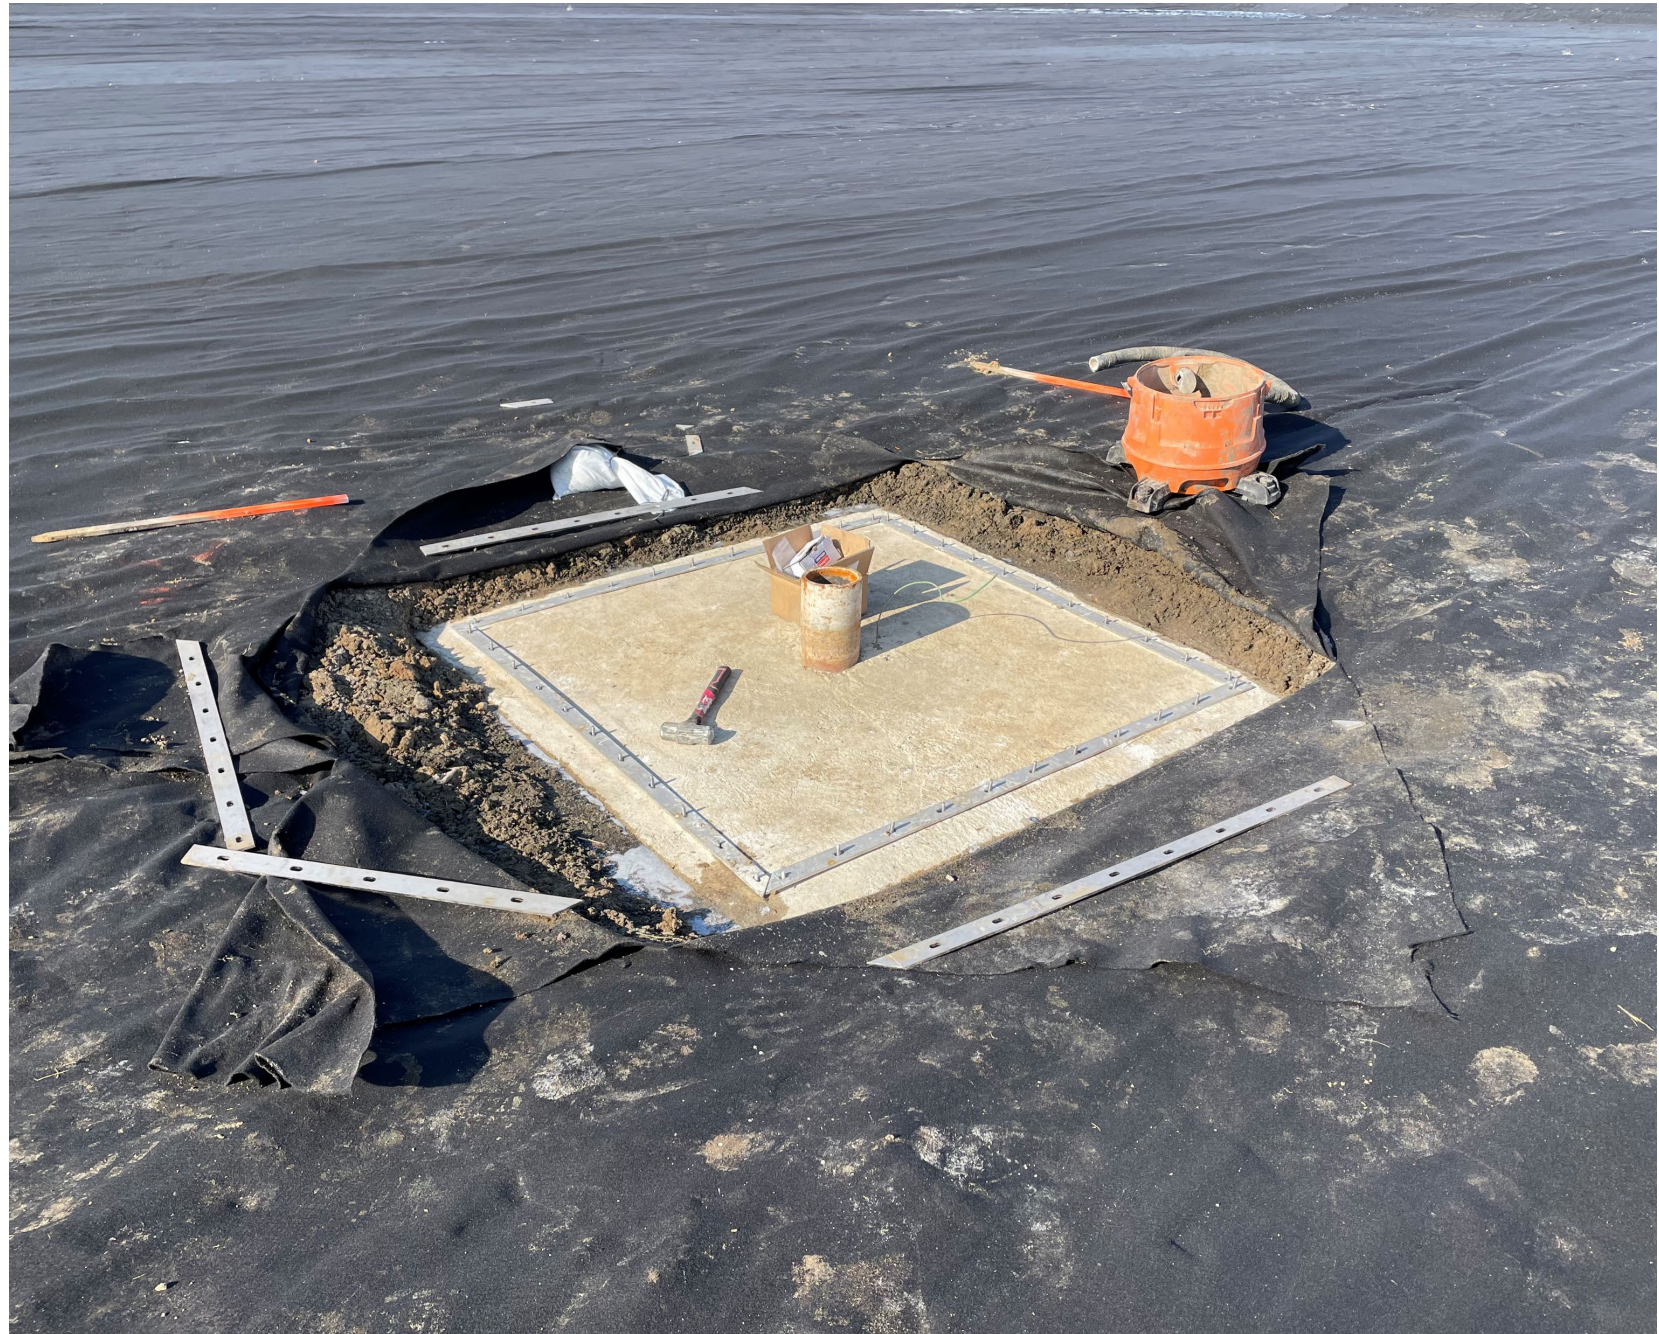
- The geotextile fabric and the HDPE liner are secured to the existing concrete influent structure using batten bars
- Anchor bolts are embedded into the concrete base
- A gasket and bottom batten are installed over the bolts
- The liner materials are pushed over the bolts and secured with a top batten
- Nuts are placed on the bolts and tightened to compress the liner to the structure

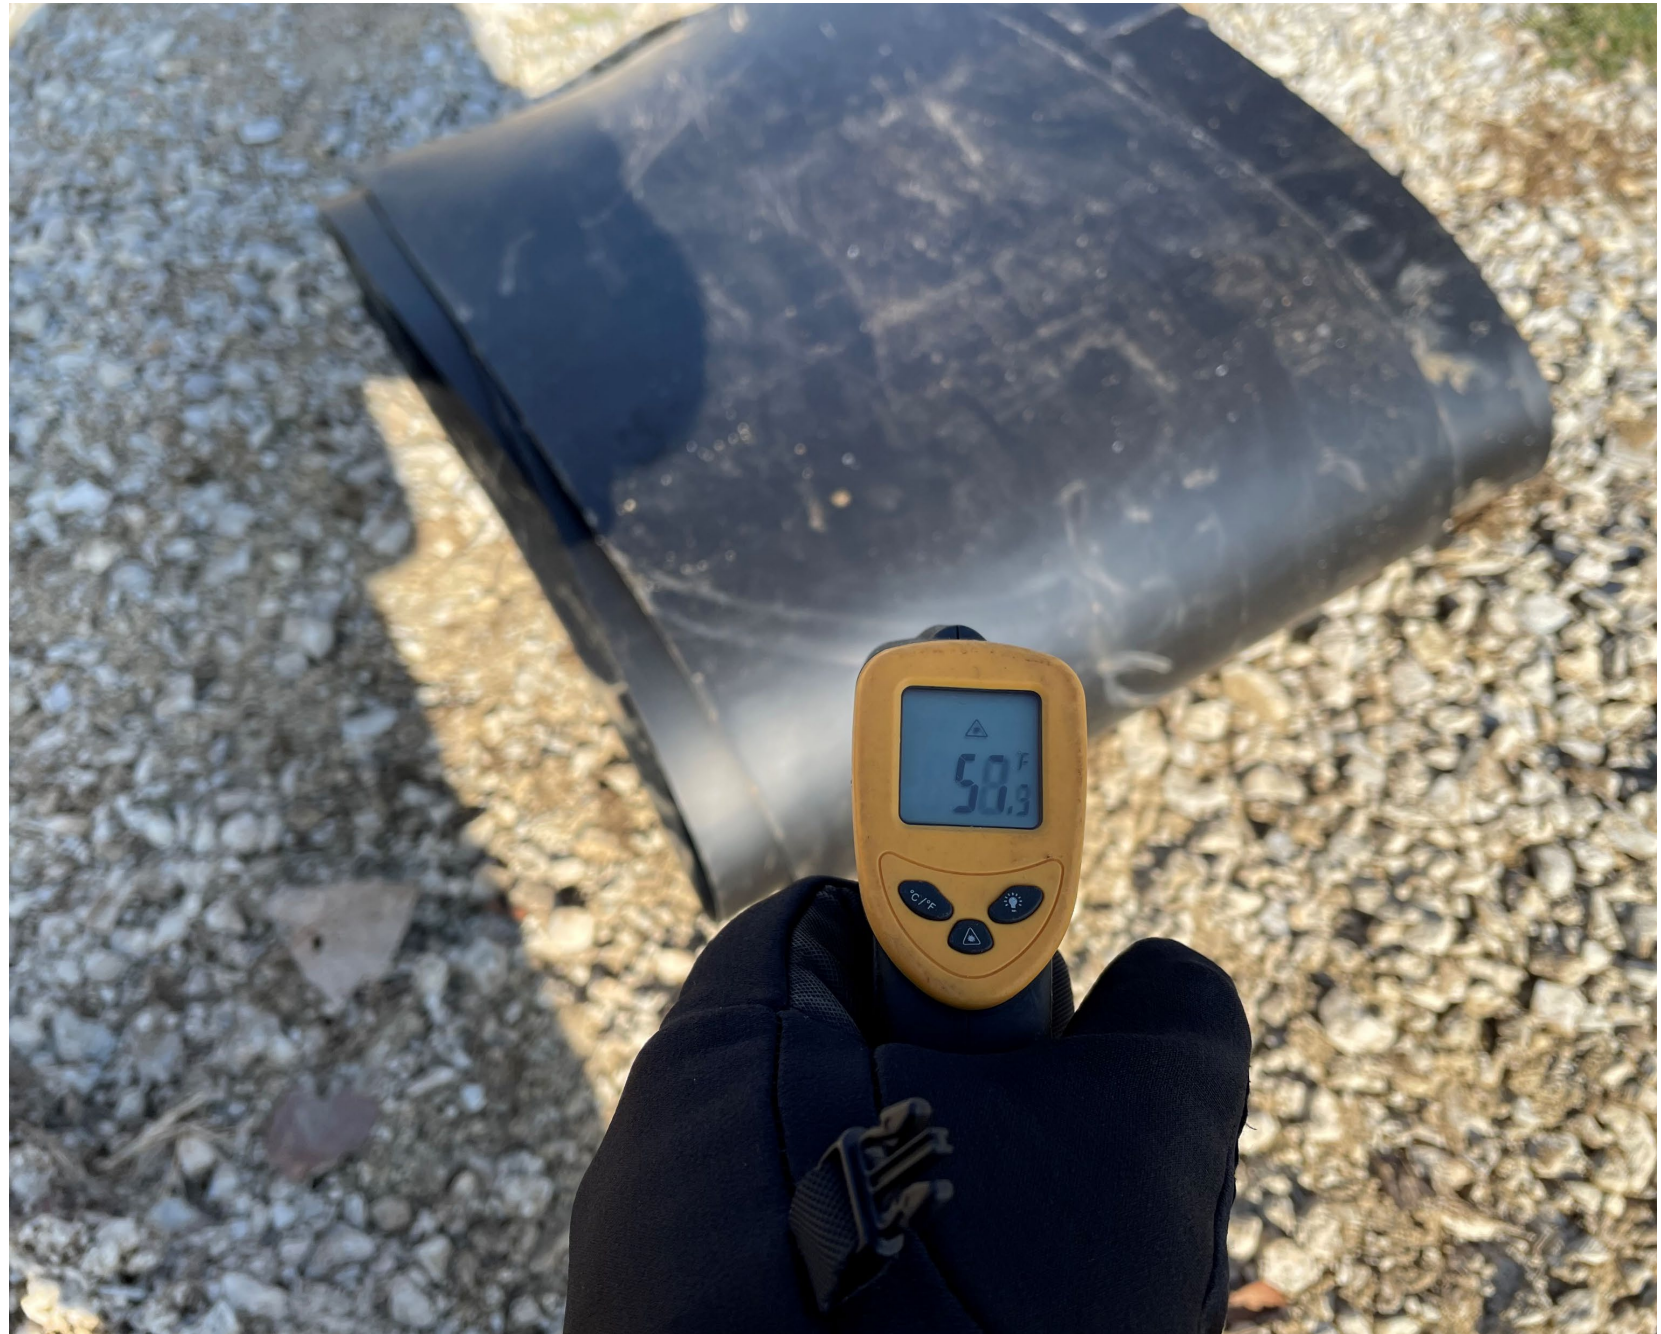
- The liner installation proceeds only when the panel temperature is above 40°F, high winds are not present, and no precipitation is occurring
- The black HDPE liner material absorbs solar radiation, the panel temperature in this picture is 57.9°F while the air temperature is 19°F

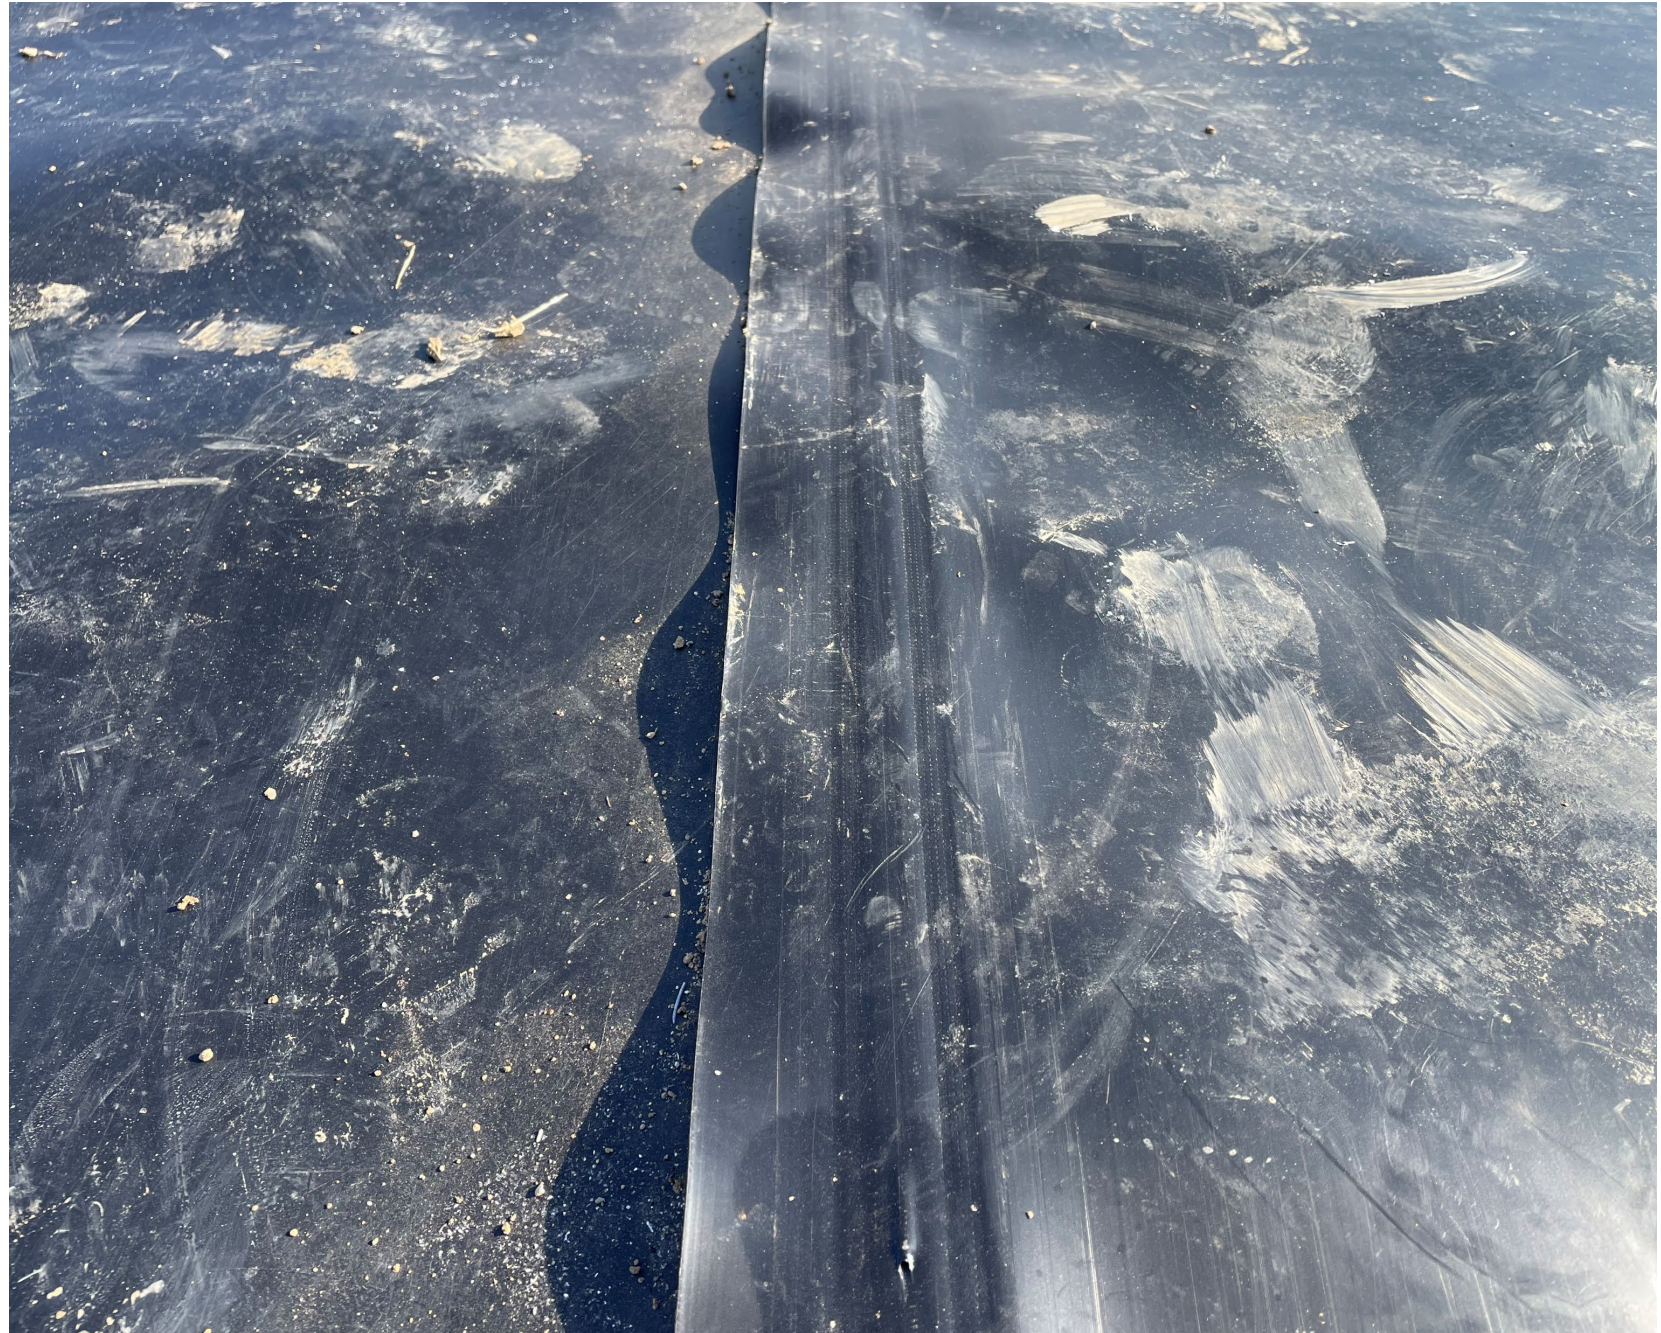
- In most locations, the HDPE liner is welded using a double-seam fusion welding machine.
- The liner seams are overlapped for fusion welding by a minimum of 4"
- The channel between the seams is air tested to between 30 and 35 psi and held for 5 minutes
- If the pressure loss does not exceed 4 psi of the starting pressure, the seam is considered leak tight
- After passing the air test, the seam is marked and initialed
- All information regarding air pressure testing is logged by the QA technician

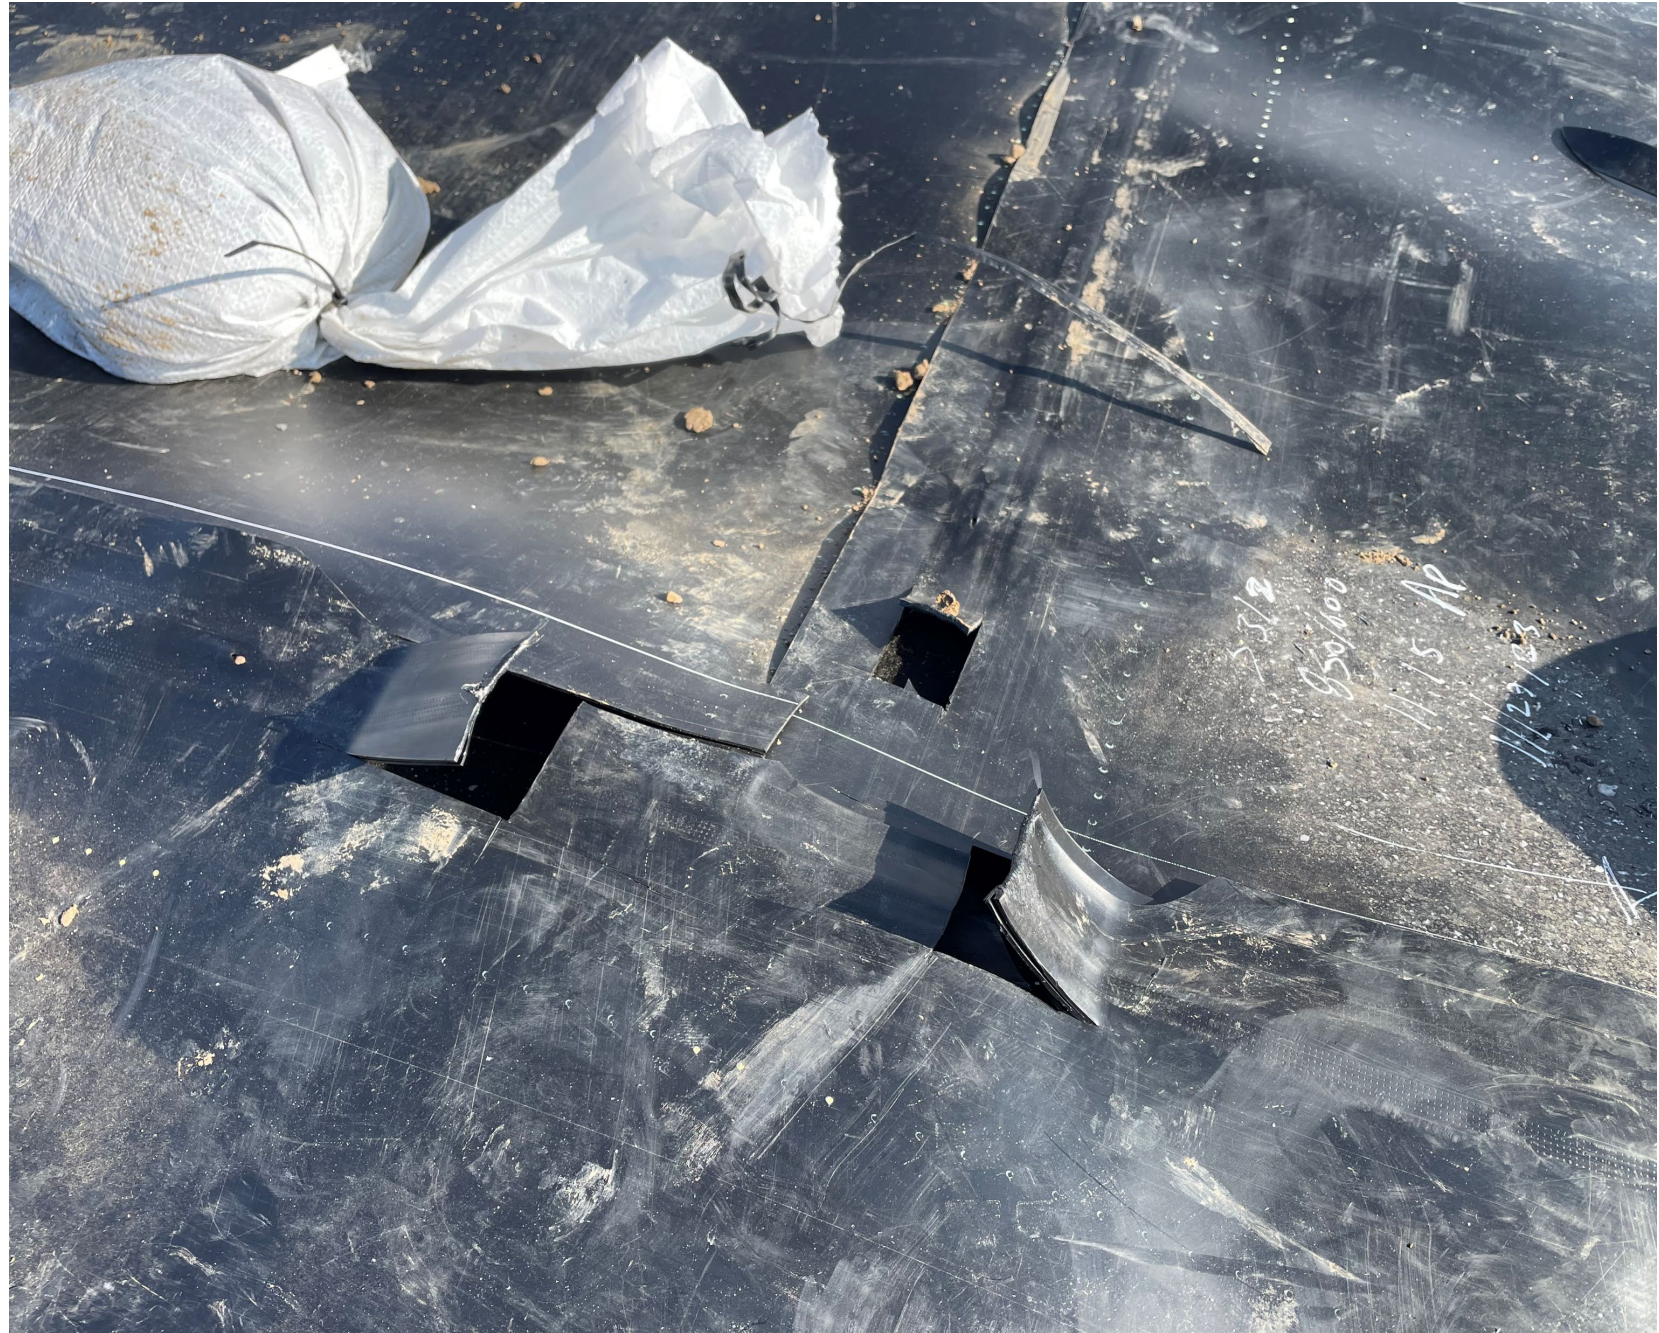
- Samples are taken at 30' intervals at transition from horizontal to sloped surfaces
- Coupons are cut from the sample, five coupons are tested in shear, and five coupons are tested in peel
- The pass/fail criteria is the same as the test seams
- The test location is patched with an extrusion welder and vacuum tested
 - Surfaces are cleaned and dried at the time of the repair
 - Patches extend a minimum of 6" beyond the edge of the defect
- The QA technician records each destructive test sample

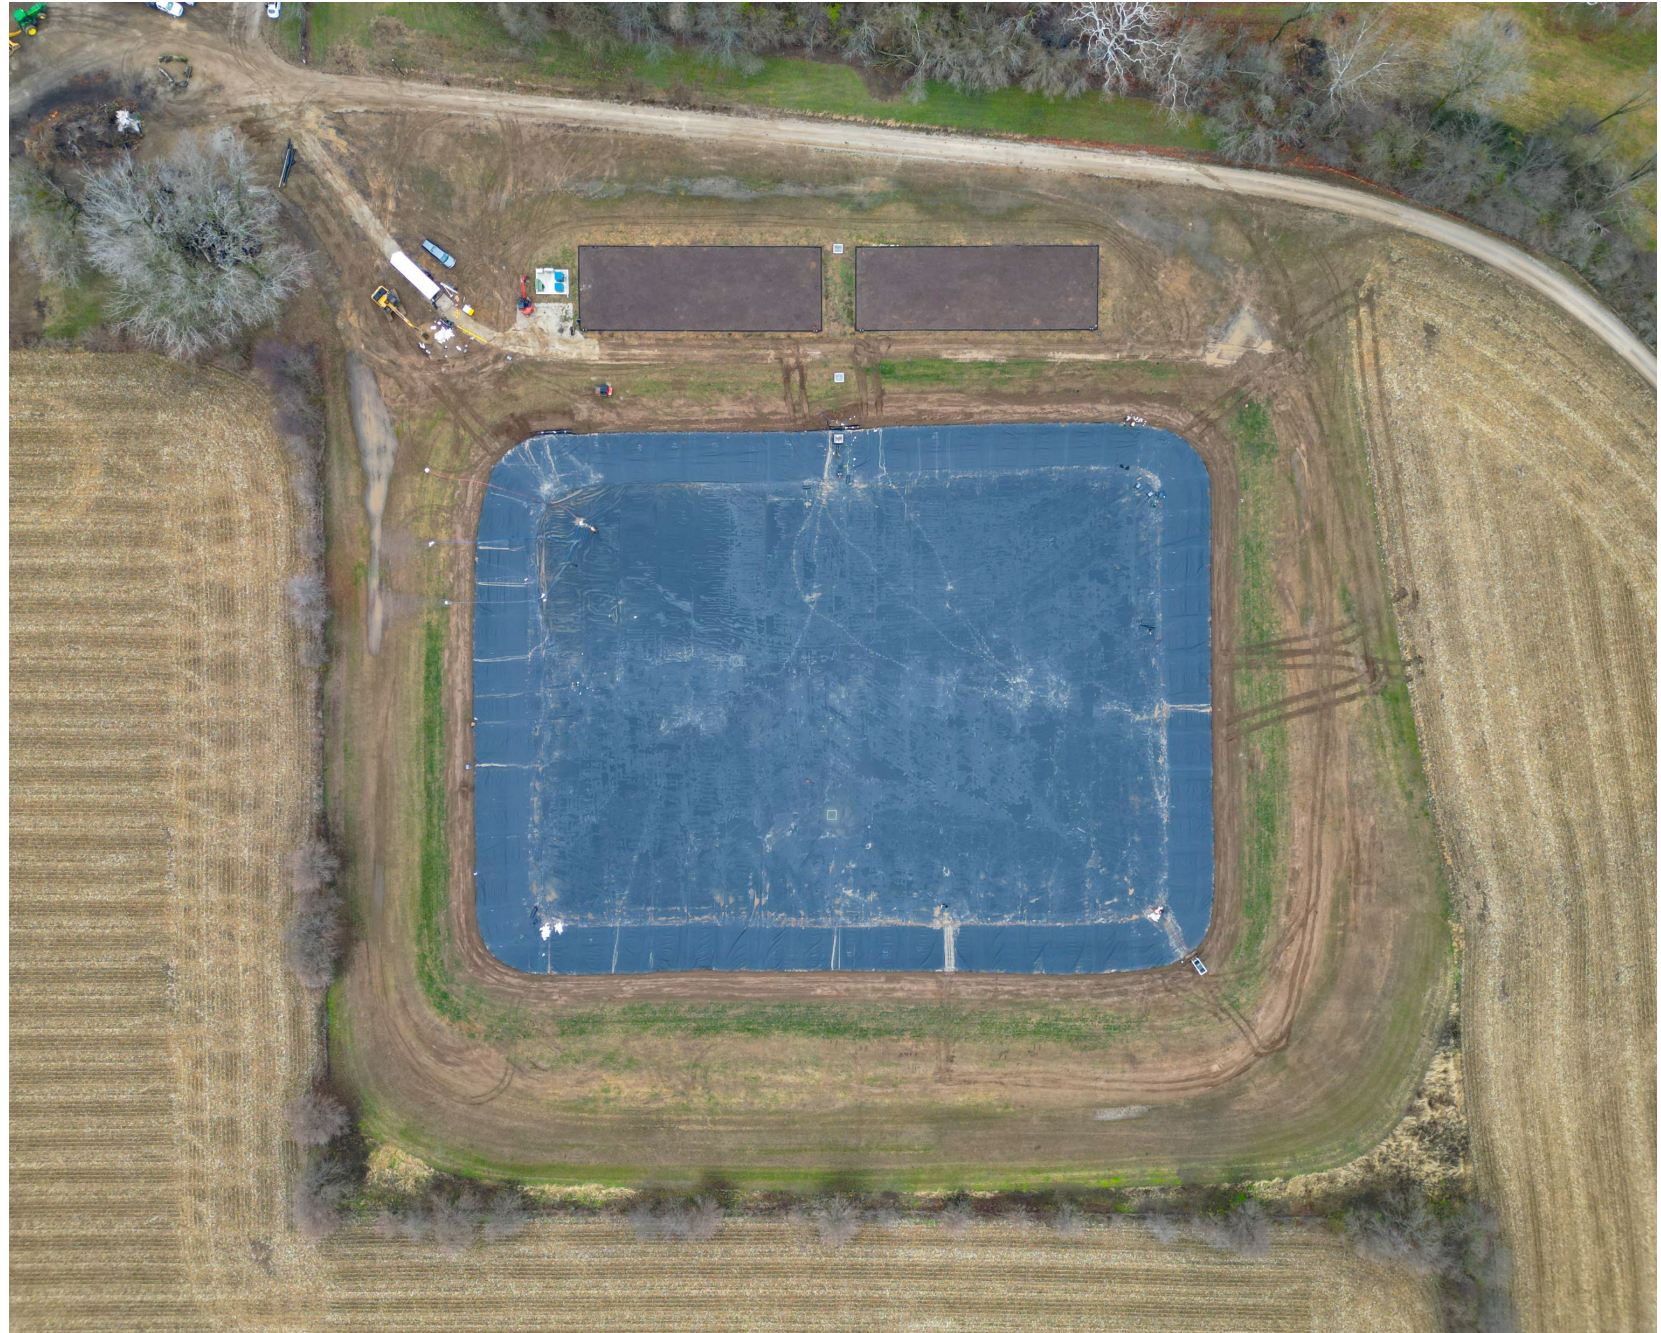
- When the work was complete, the QA technician conducted a final walk-thru of the liner installation to verify that all repairs were appropriately performed, all tests results were positive, and the area was cleared of all scrap, trash, and debris
- The anchor trench was backfilled
- A Certificate of Completion was signed, this document transfers title from IEC to the Town of Thorntown
- Warranties are as follows:
 - One (1) year from date of substantial completion, guaranteeing the workmanship of the installation
 - Five (5) years material warranty
